PASSAIC RIVER BASIN
TROY BROOK, MORRIS COUNTY
NEW JERSEY

LEVEL
CRYSTAL LAKE DAM
NJ 00169

PHASE 1 INSPECTION REPORT
NATIONAL DAM SAFETY PROGRAM

Crystal Lake Dam, NJ-00169.
Passaic River Basin. Troy Brook,
Morris County, New Jersey.
Phase I Inspection Report.

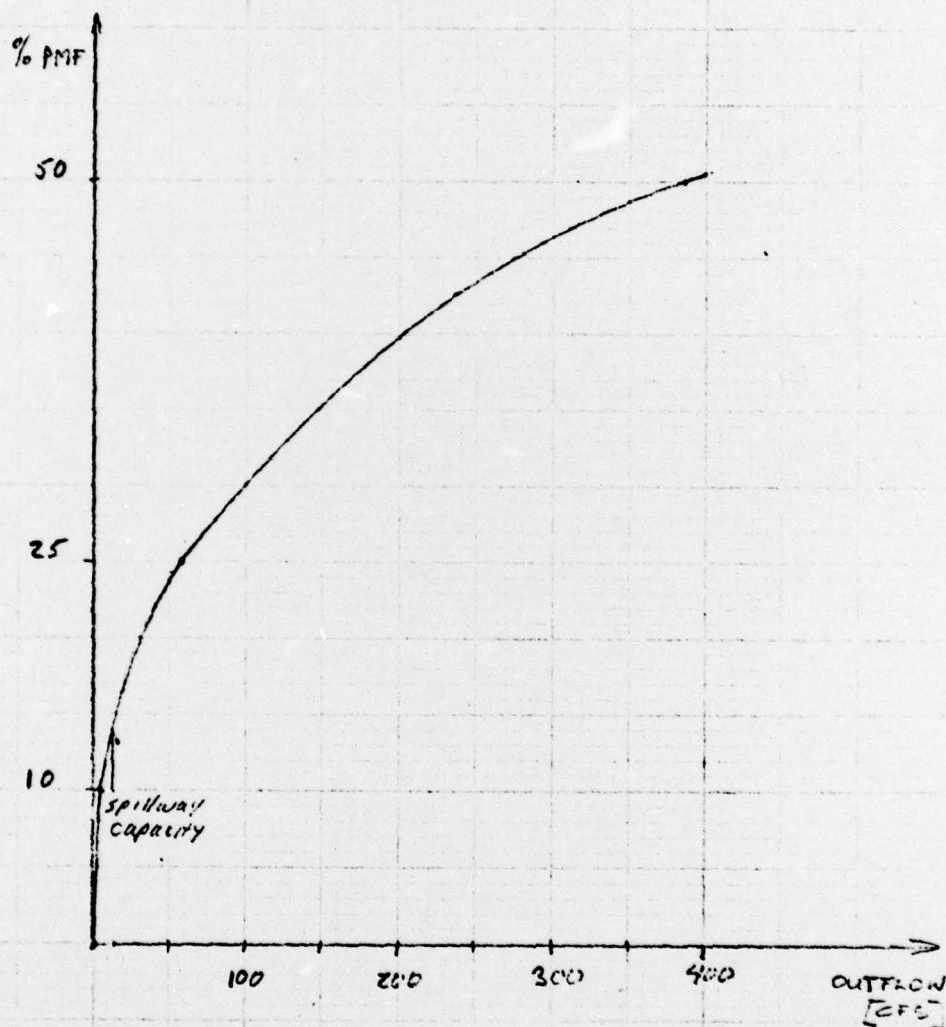
DAM OVERTOPS AT APPROX. ELEVATION 536, FEET MSL
WITH $Q = 7$ CFS

∴ SPILLWAY CAN PASS ~ 14% of PMF
